Building Maintenance Affects Indoor Air Quality

By **Wane A. Baker, P.E., CIH**, Member ASHRAE

The subject facility is a large, suburban high school located in a major metropolitan area of the upper Midwest. The original design of this building was based on an open floor concept, but the classroom spaces were extensively remodeled in the early 1990s.

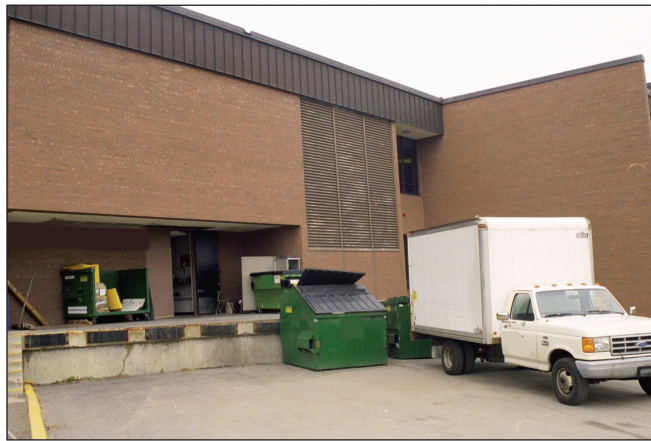
- The outdoor air intake louver for six primary AHUs was located immediately adjacent to the loading dock, resulting in the intake of truck exhaust and odors from trash receptacles (*Photo 1*). We also noted that school personnel would occasionally use tobacco in the area shielded from view by the trash container.

Photo 1: Truck exhaust and odors entered the building at the school's loading dock.

- Revise the outdoor air intake currently located near the loading dock to draw outdoor air from above the roofline to reduce the frequency of entraining fumes and exhaust.

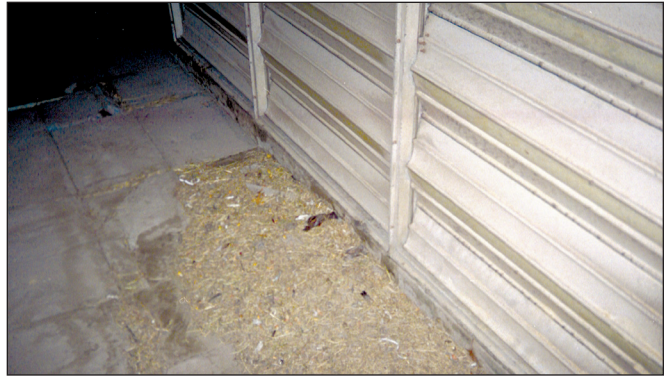
- The bird screen behind the OA intake louver had failed, resulting in an accumulation of organic debris and numerous sparrow carcasses within the OA plenum serving the six primary AHUs (*Photo 2*).

Photo 2: A bird screen failed behind the outdoor air intake louver, allowing organic debris into the air plenum.
