Look Below Surface For IAQ Problems

By Wane A. Baker, P.E., CIH, Member ASHRAE

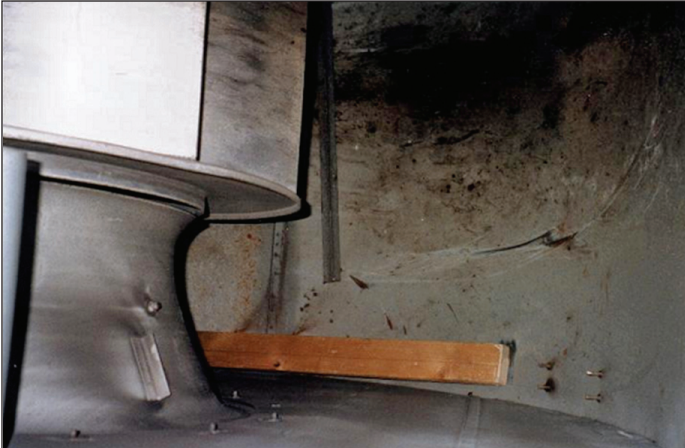
Photo 1: A length of angle iron and a section of lumber were found in the scroll of the supply air fan. Apparently, both had been there since the time of original construction.

Additionally, we conducted a visual and robotic inspection of ductwork, terminal units, coils and the interiors of the air-handling units (AHUs). In the process of this inspection, we found foreign objects in the scroll of the classroom supply air fan (see *Photo 1*), and severely damaged fibrous glass interior insulation in the ductwork and AHUs, resulting in obstructed coils, balancing dampers and turning vanes (see *Photos 2 and 3*).

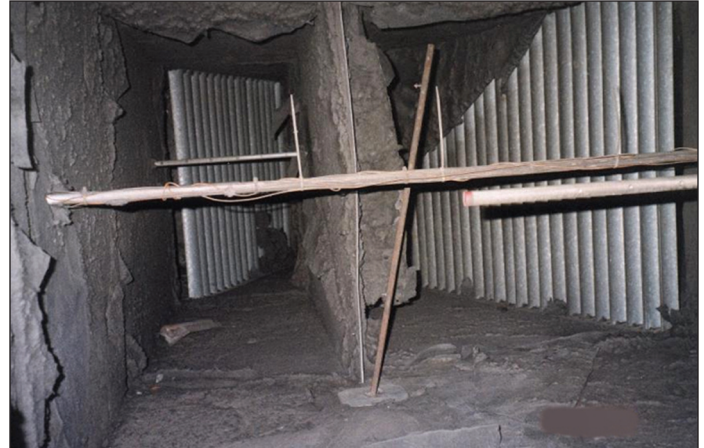
Photo 2: The high velocity, turbulent airstream severely damaged interior fibrous glass insulation just downstream of the supply fan's blast zone.

The district faced an additional expenditure of more than \$150,000 to remove the damaged fibrous glass insulation, clean-up the distributed glass fibers, reinsulate affected sections, and rebalance the air conveyance system.

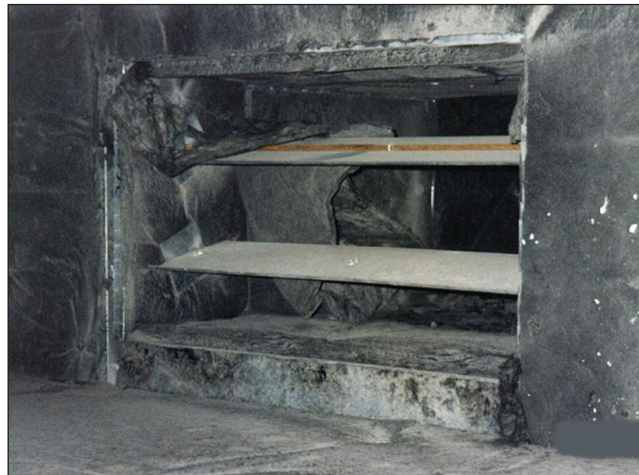
Photo 3: Large sections of the interior fibrous glass insulation had released from the metal ductwork, becoming lodged in balancing dampers.
