**Energy Audit  
Department of Housing  
and Urban Development**

**Housing Authority of the  
City of La Crosse  
La Crosse, WI**

**Becker Plaza**

**Michael's No.: H3406AAN  
June 2006**

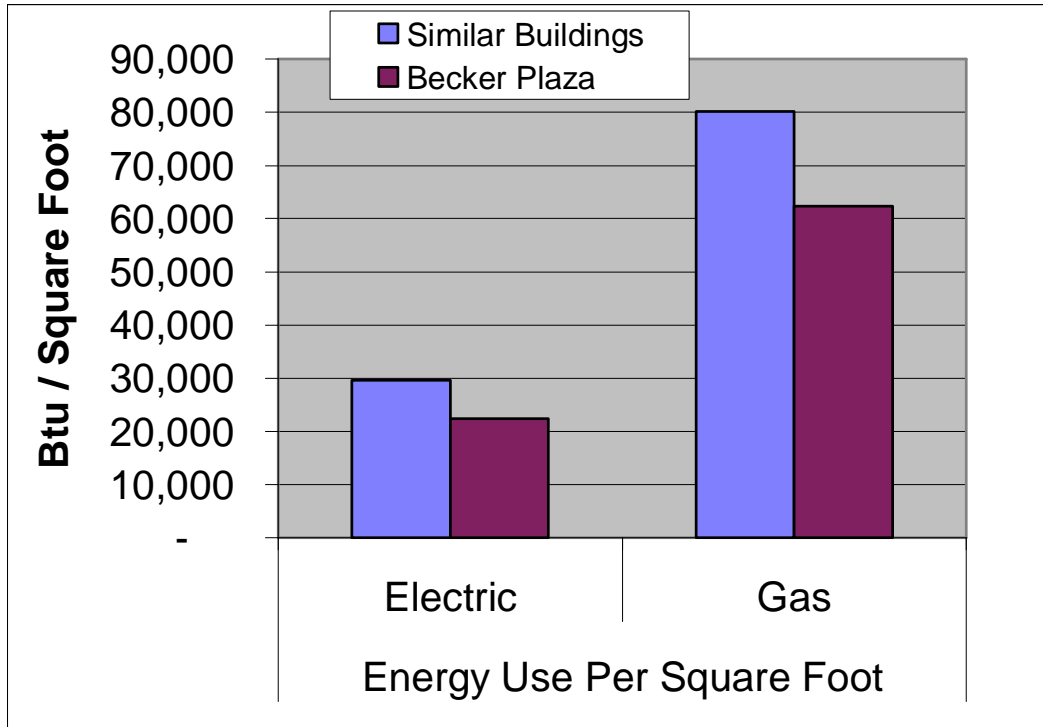
Energy intensity is used to compare the efficiency of facilities, as a whole, with similar facilities in similar climates. The US Department of Energy's Energy Information Administration database was used to develop a comparison of this building's energy use to that of similar buildings. The database was filtered for geographical area, principle use, and building size.

Figure 1 Energy Intensity Comparison to Similar Facilities

This facility uses substantially less energy than similar buildings and this is confirmed by the lack of many substantial energy opportunities noted in this report.

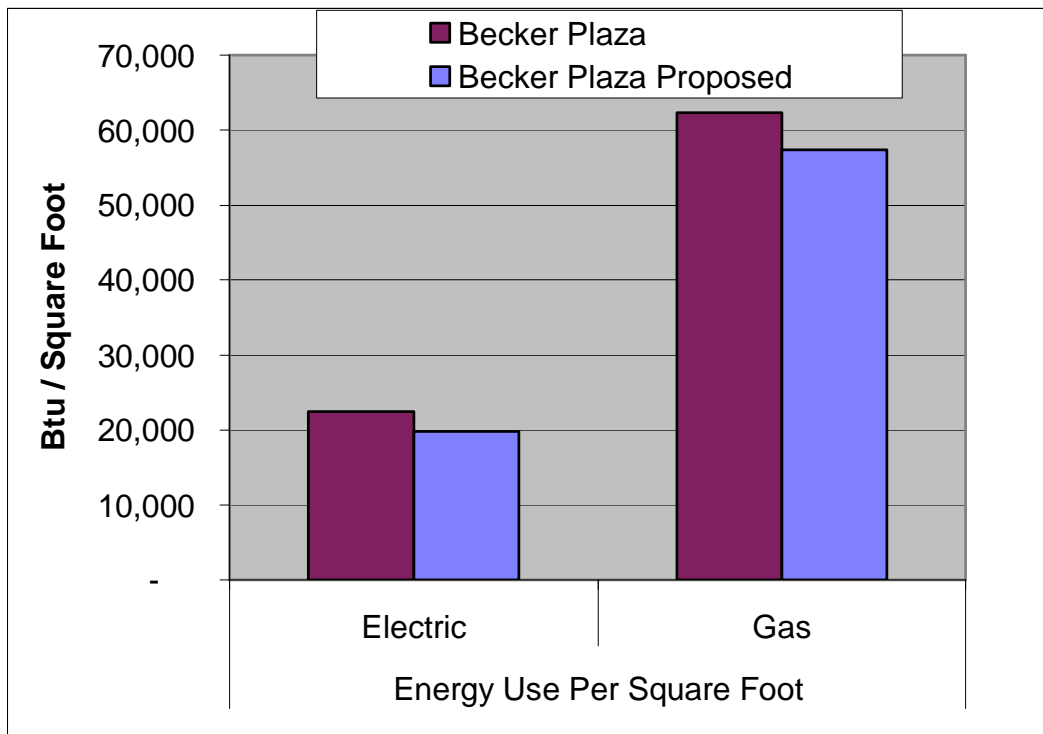
Implementing the energy projects shown in Table 2 would reduce annual energy costs by over \$6,000. Gas and electric costs will each be reduced by approximately 9% and 14% respectively. The combined payback of the projects is 6.4 years. Figure 3 below shows the existing energy use of Becker Plaza compared to the proposed energy use of the building if the recommended projects are implemented.

Figure 3 Energy Intensity Comparisons before and after Project Implementation
